# Manhole Inspection Summary

Manhole # S290\_\_028MH

Insp Date: **11/18/08 10:19 AM**

**Location** Address: **1111 W. West**

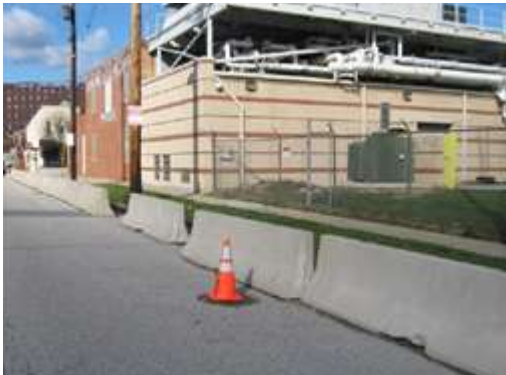
Location View

1111 W West St

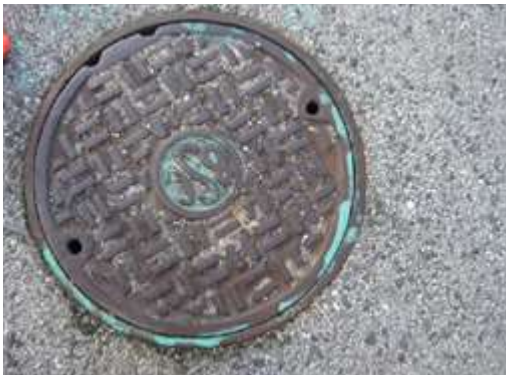
mh cover

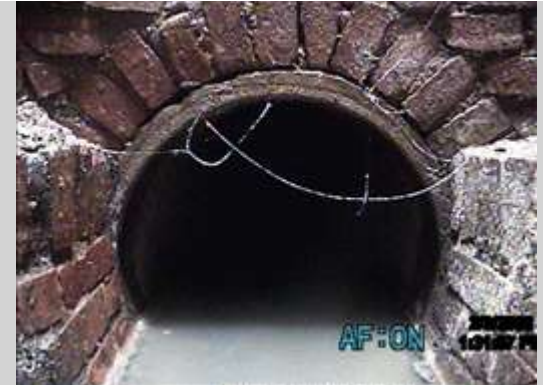
12 O'Clock Outflow

18 in. Circular Gravity Sewer  
Pipe Out @ 12 O'Clock

Pipe Height: **18** (in.) Rod and Bar (Angled)  
Pipe Material: **Clay** ☐ Pipe Lined  
Invert Depth: **13.40** (ft.) Flow Characteristics: **Fast**  
Deposits: ☒ None ☐ Mud ☐ Gravy ☐ Debris ☐ Grease  
Silt Depth: **0** (in.) Deposits Extent:  
Infiltration: **None** Pipe Seal Cond: **Sound**

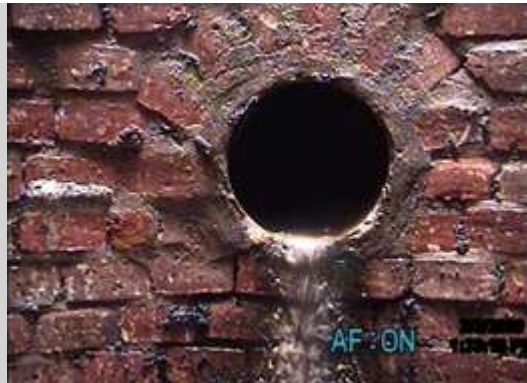
9 O'Clock Inflow

8 in. Circular Gravity Sewer

Pipe In @ 9 O'Clock

Pipe Height: **8.4** (in.) Rod and Bar (Angled)

Deposits: ☒ None ☐ Mud ☐ Sludge ☐ Debris ☐ Grease

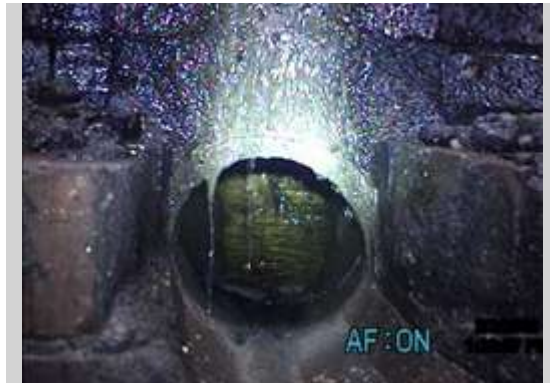
Drop In @ 9 O'Clock

Drop: **Inside** Rod and Bar  
Angled: **Yes** Reading: **11.40** (ft.)  
Inv Depth: **12.40** (ft.)  
Drop Condition: **Open**

Connects To: **House connection / Service line**
